**REPORT OF HAZARDOUS MATERIALS SURVEY**

**BUZZARD POINT  
WASHINGTON, DC**

**ECS PROJECT NO. 37:1524**

**JULY 28, 2015**

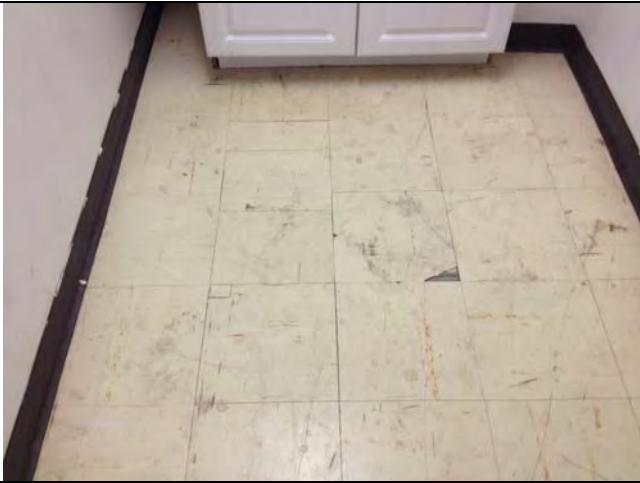
1. 1714 2<sup>nd</sup> St: View of 12" x 12" Off-White Floor Tile (ACM) in the 2<sup>nd</sup> Floor Kitchen. Sample No. BS-5-A.

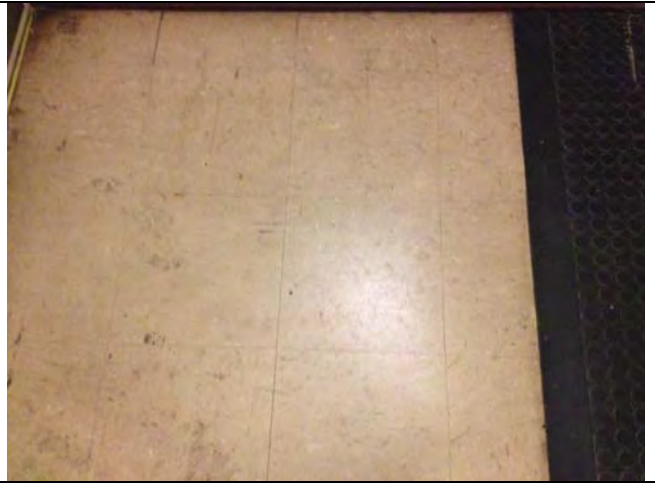
2. 1714 2<sup>nd</sup> St: View of 12" x 12" Tan Floor Tile (ACM) in the Stairwell. Sample No. BS-9-A.

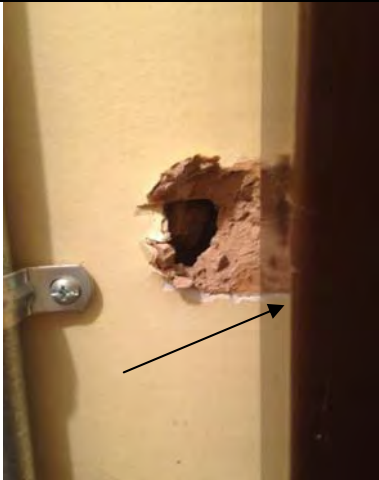
3. 1714 2<sup>nd</sup> St: View of Drywall Joint Compound (ACM) associated with Brown Drywall in the 2<sup>nd</sup> Floor Closet. Sample No. BS-13.

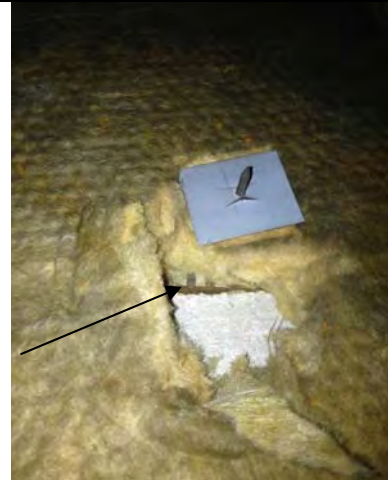
4. 1714 2<sup>nd</sup> St: View of Brown Pin Mastic (ACM) associated with Fiberglass Insulation in the 2<sup>nd</sup> Floor Conference Room. Sample No. BS-28.

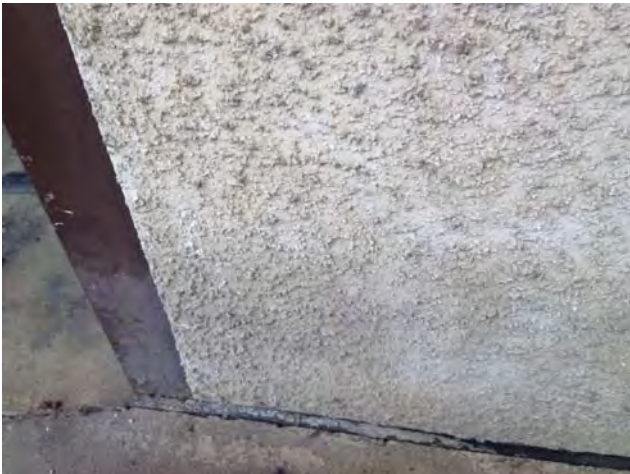
5. 1714 2<sup>nd</sup> St: View of Exterior Wall Texture Coating (ACM). Sample Nos. BS-39 – BS-45.

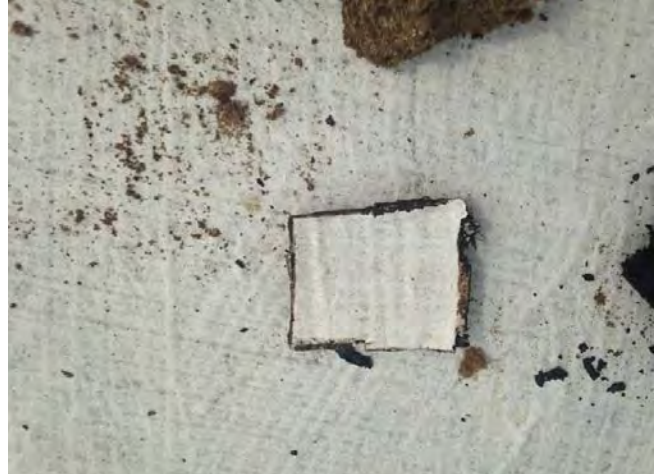
6. 1714 2<sup>nd</sup> St: View of Top Roof Layer (ACM). Sample No. BS-57.

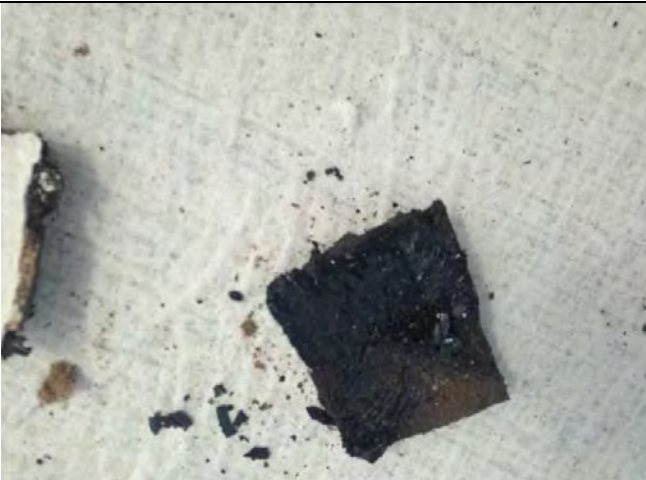
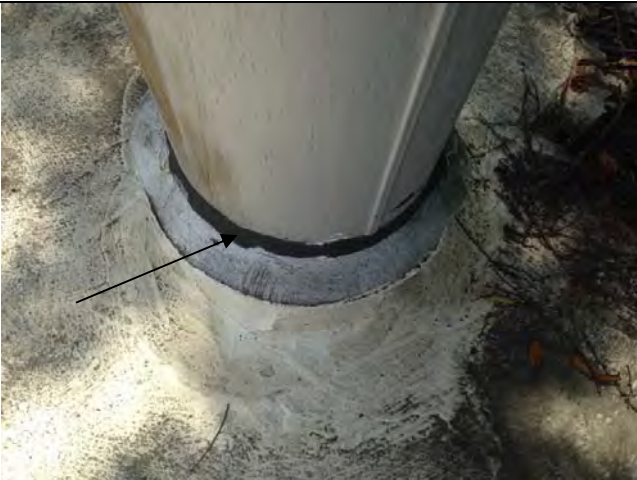
<p>7. 1714 2<sup>nd</sup> St: View of 2<sup>nd</sup> Roof Layer (ACM). Sample No. BS-68.</p>	<p>8. 1714 2<sup>nd</sup> St: View of Black Vent Caulk (ACM) on the Roof. Sample No. BS-61.</p>

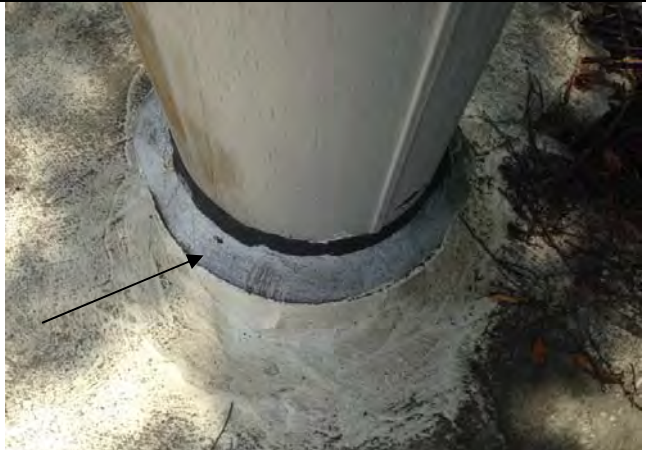
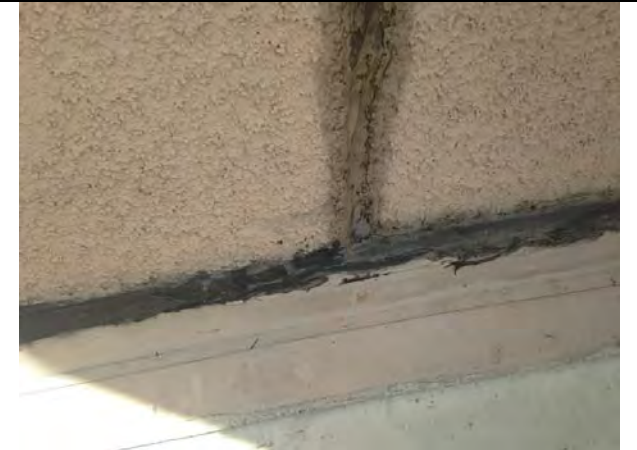
<p>9. 1714 2<sup>nd</sup> St: View of Silver Paint (ACM) on the Roof Vents. Sample No. BS-65.</p>	<p>10. 1714 2<sup>nd</sup> St: View of Caulking (ACM) on the Roof Flashing. Sample No. BS-64.</p>

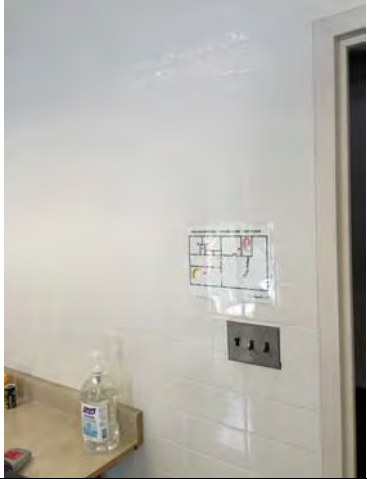
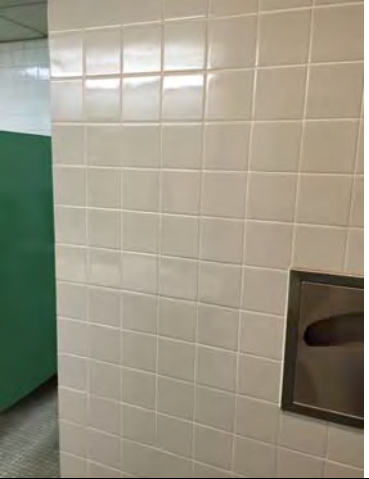
<p>11. 1714 2<sup>nd</sup> St: View of Lead-Based Glaze on White Ceramic Wall Tiles in the 2<sup>nd</sup> Floor Break Room. XRF Reading No. 52.</p>	<p>12. 1714 2<sup>nd</sup> St: View of Lead-Based Glaze on Grey Ceramic Wall Tiles within the Men's Bathroom. XRF Reading No.56.</p>	
<p><b>BUZZARD POINT PROPERTIES</b> <b>WASHINGTON, DC 20024</b> <b>ECS PROJECT NO. 37:1524</b></p>

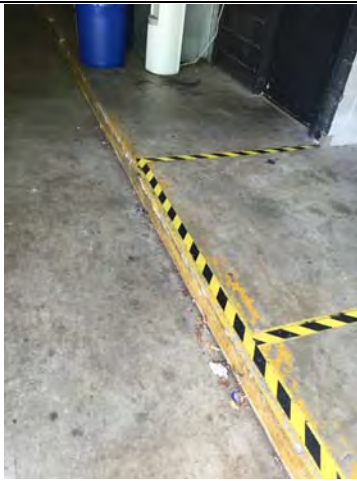
13. 1714 2<sup>nd</sup> St: View of Lead-Based Paint on Yellow Concrete Curb in the Garage. XRF Reading No. 121.

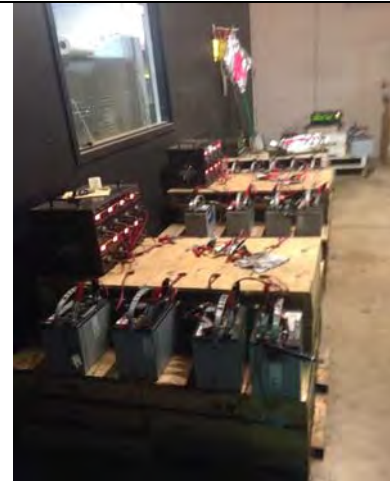
14. 1714 2<sup>nd</sup> St: View of Batteries in Garage.

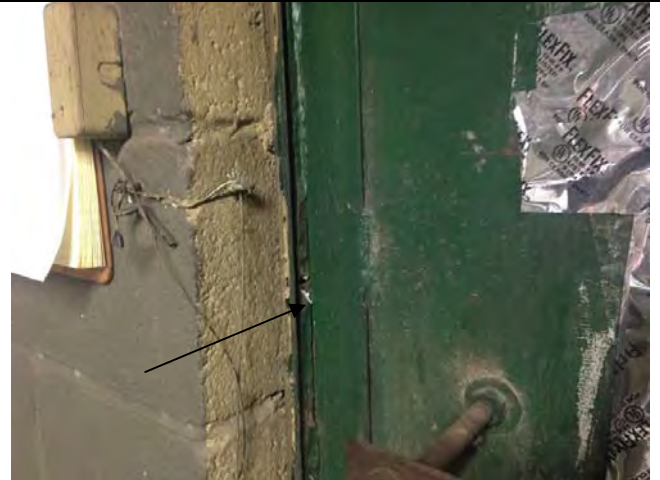
16. 1711 1<sup>st</sup> St: View of Gray Interior Window Caulk (ACM) in the Rear Office. Sample No. SS-05.

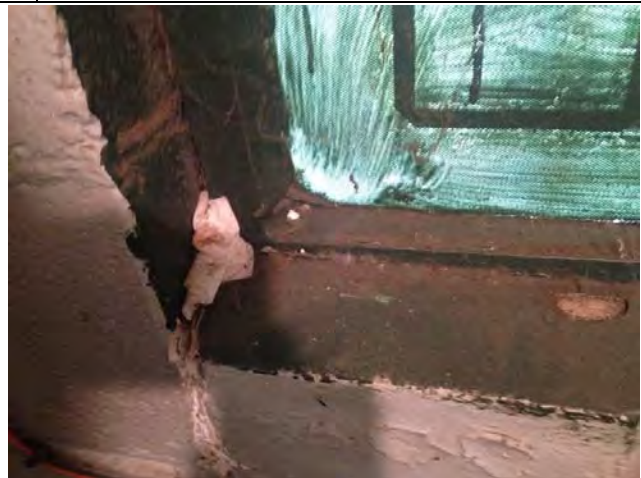
17. 1711 1<sup>st</sup> St: View of White Interior Window Glaze (ACM) in the Rear Office Bathroom. Sample No. SS-07.

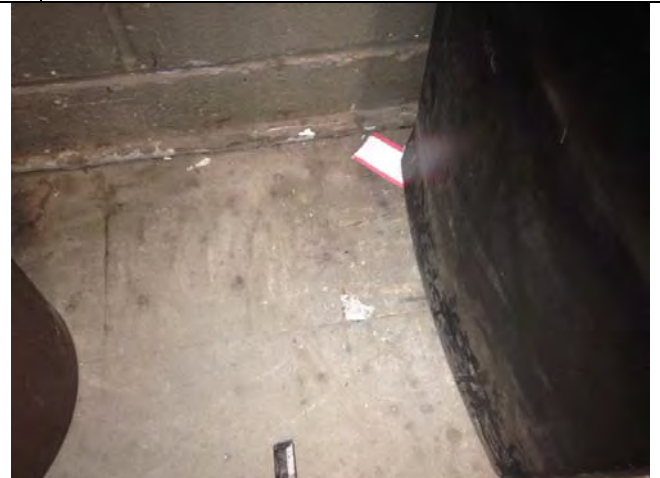
18. 1711 1<sup>st</sup> St: View of 12" x 12" Tan Floor Tile (ACM) in the Front Office. Sample No. SS-09.

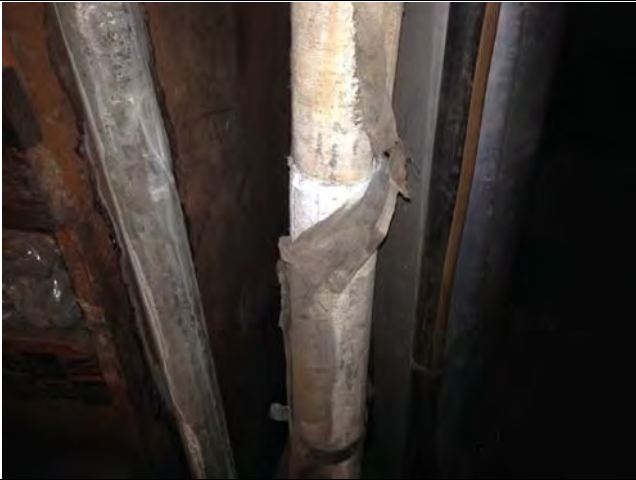
ACM pipe insulation sampled on the second floor storage area in the Super Salvage Building was observed throughout the building.

19. 1711 1<sup>st</sup> St: View of Pipe Insulation (ACM) in the 2<sup>nd</sup> Floor Storage Area. Sample No. SS-15.

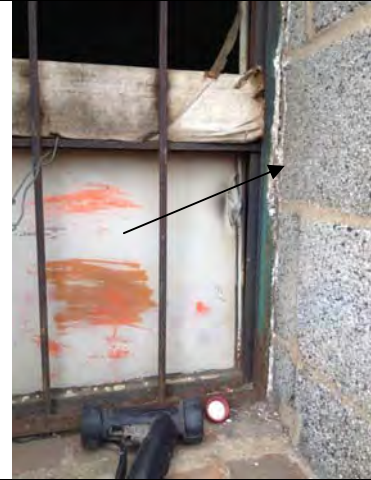
20. 1711 1<sup>st</sup> St: View of White Exterior Window Caulk (ACM). Sample No. SS-19.

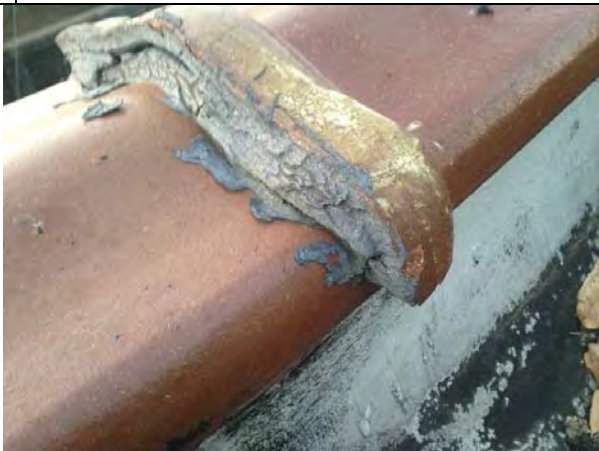
21. 1711 1<sup>st</sup> St: View of Gray Copping Stone Caulk (ACM) on the Roof. Sample No. SSR-13.

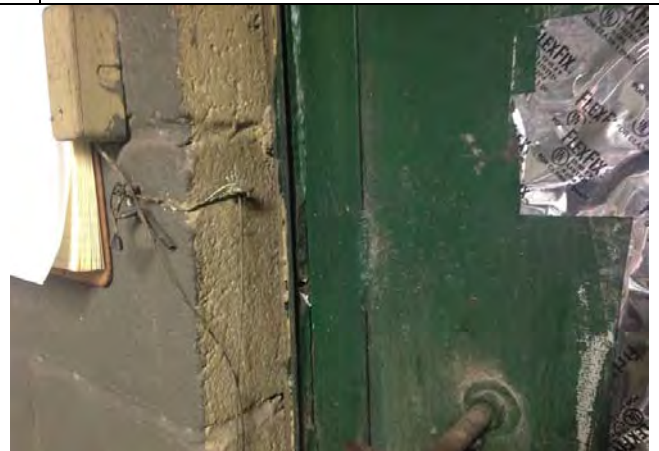
22. View of Lead-Based Paint on Green Metal Window Apron in the Rear Office. XRF Reading No. 9.

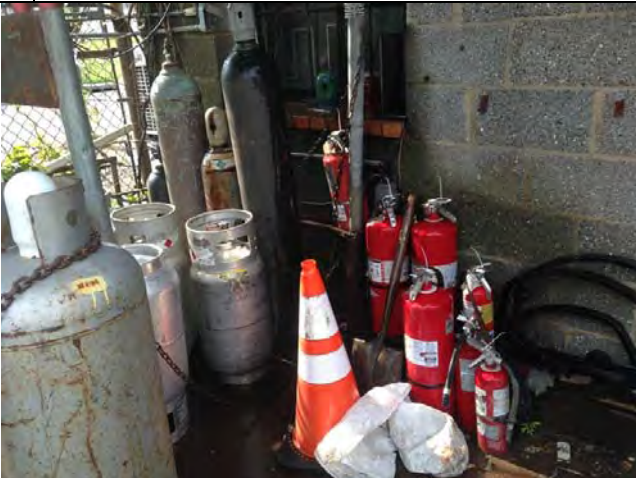
23. 1711 1<sup>st</sup> St: View of Compressed Gas Containers and Fire Extinguishers.

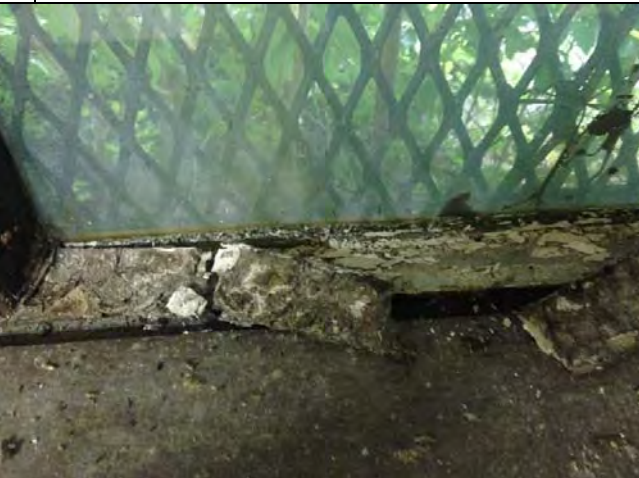
19. 2<sup>nd</sup> and S St: View of White Interior Window Glaze (ACM) in the Warehouse Office. Sample No. AW-07.

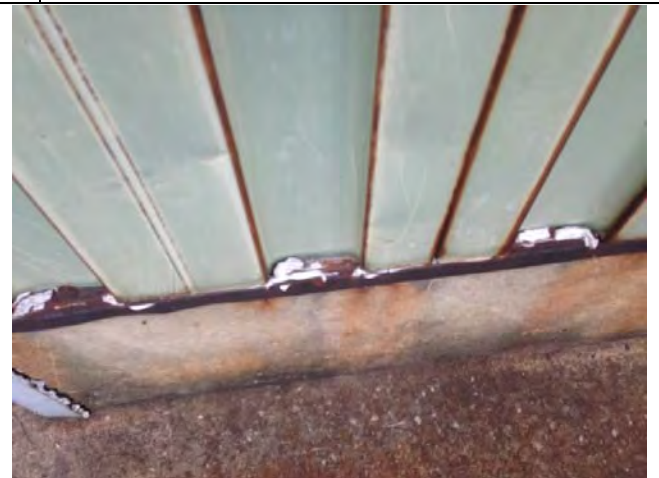
30. 2<sup>nd</sup> and S St: View of Exterior White Siding Caulk (ACM). Sample No. AW-15.

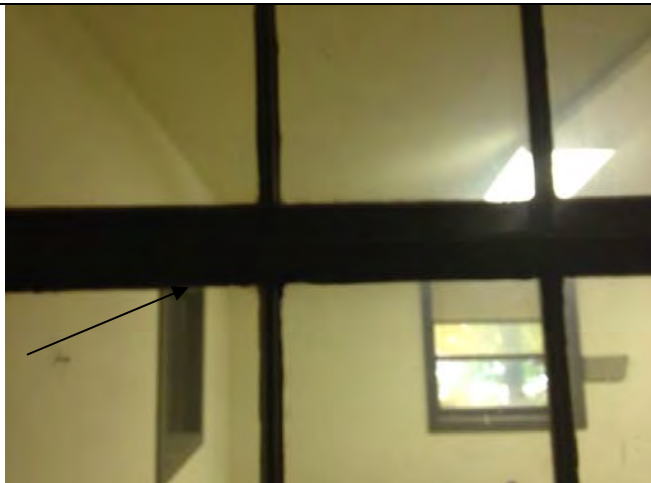
31. 2<sup>nd</sup> and S St: View of Lead-Based Paint on Brown Wood Window Sash in the Warehouse Office. XRF Reading No. 12.

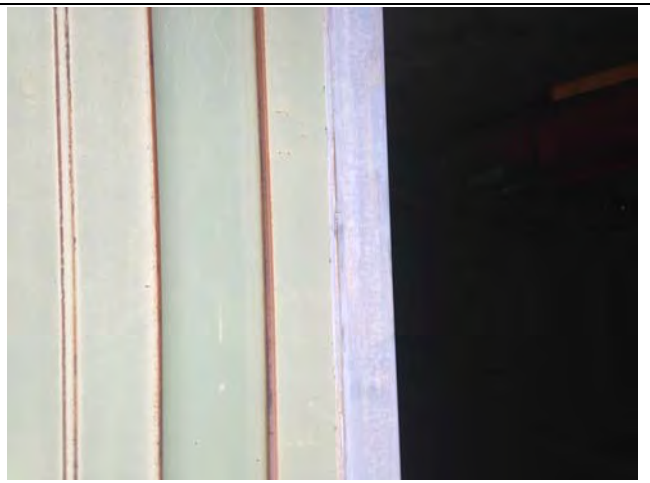
32. 2<sup>nd</sup> and S St: View of Lead-Based Paint on Gray Metal Exterior Door Casing. XRF Reading No. 08.
